Investigation of Controlled Flight into Terrain

U. S. Department
Of Transportation
**Federal Aviation
Administration**

Descriptions of Flight Paths for Selected Controlled Flight into Terrain (CFIT) Aircraft Accidents, 1985-1997

Project Memorandum
DOT-TSC-FA9D1-99-01
March 1999

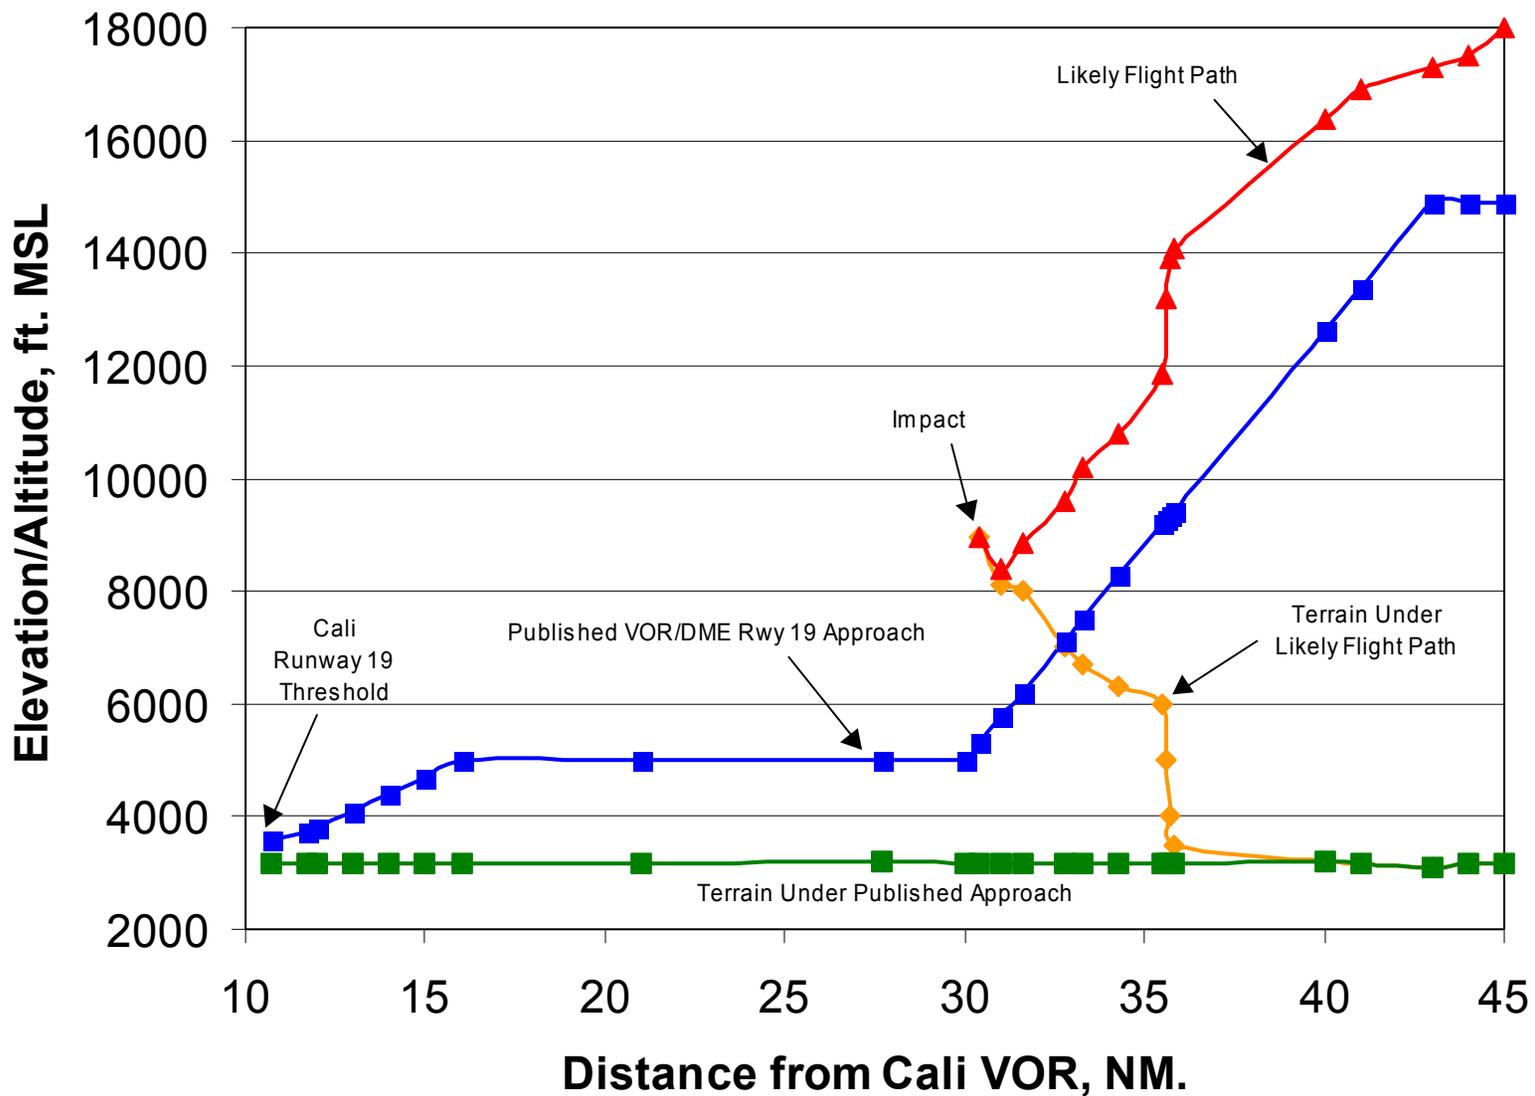
Figure 12.
Buga, Colombia -- B757-200 -- N651AA -- 12/20/95

The Buga accident involved American Airlines flight 965, a Boeing B-757-200 turbofan on a regularly scheduled FAR Part 121 flight from Miami, FL to Cali, Colombia. The aircraft impacted a ridge on San Jose Mountain, which rises above the town of Buga to 12,900' MSL at its highest point, at approximately the 8960' elevation, on a heading of 221° magnetic, while the aircraft was in approach configuration. Impact was 30.4 NM from the Cali VOR facility. Of the 167 persons aboard, only four passengers survived with serious injuries. Weather in the accident vicinity was classified as dark night, VMC.

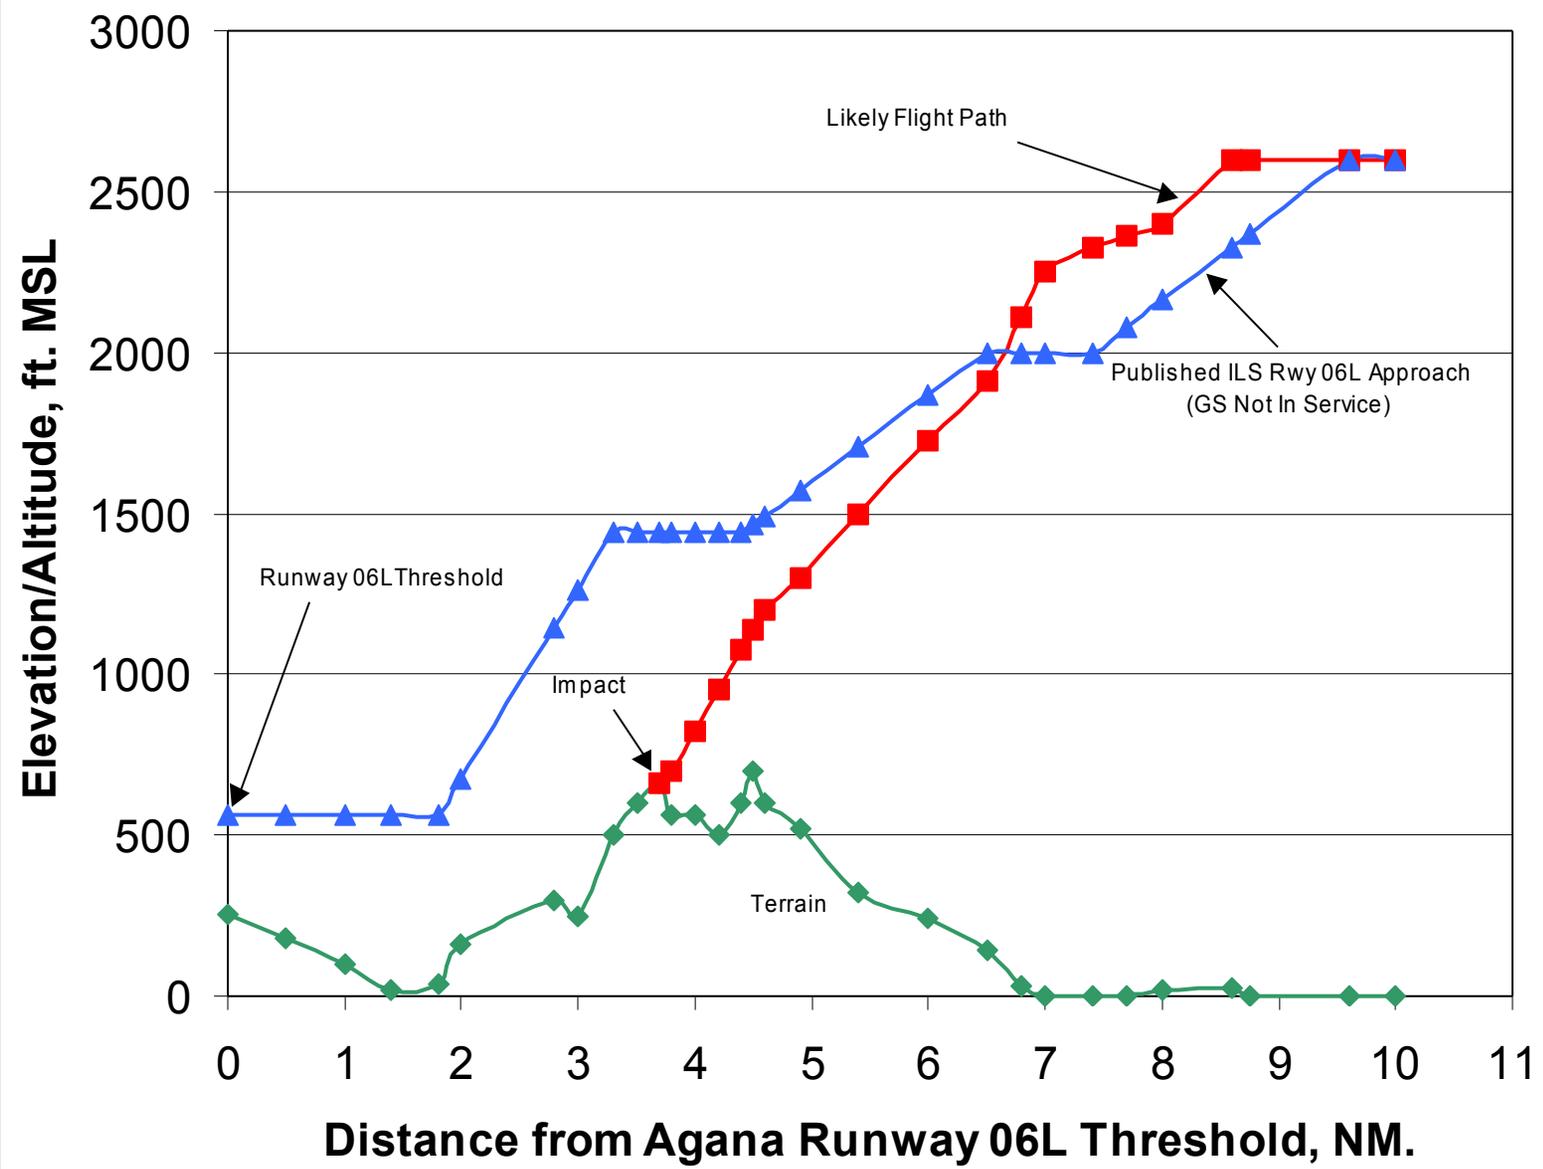
Figure 13.
Nimitz Hill, Guam -- B-747-300 -- HL-7468 -- 8/6/97

The Nimitz Hill accident involved Korean Airlines flight 801, a Boeing B-747-300 turbofan, on a regularly-scheduled FAR Part 129 flight from Seoul, South Korea to Agana, Guam. The aircraft, on an ILS approach to Runway 06L at Guam's Won Pat Airport, impacted Nimitz Hill, a 700' MSL peak, at the 662' elevation, and 3.7 NM from the runway threshold. At impact, the aircraft was in landing configuration on a heading of 063° magnetic, on course for Runway 06L. Of the 254 persons aboard, 229 were killed, and 25 survived with serious injuries. Weather in the accident vicinity was classified as dark night, IMC.
